**Accident** of Socata TB20  
registered **D-SLHS**  
occurred on November 25, 2016  
at Jarsy (73), altitude 6690 ft

**Collision with Terrain**

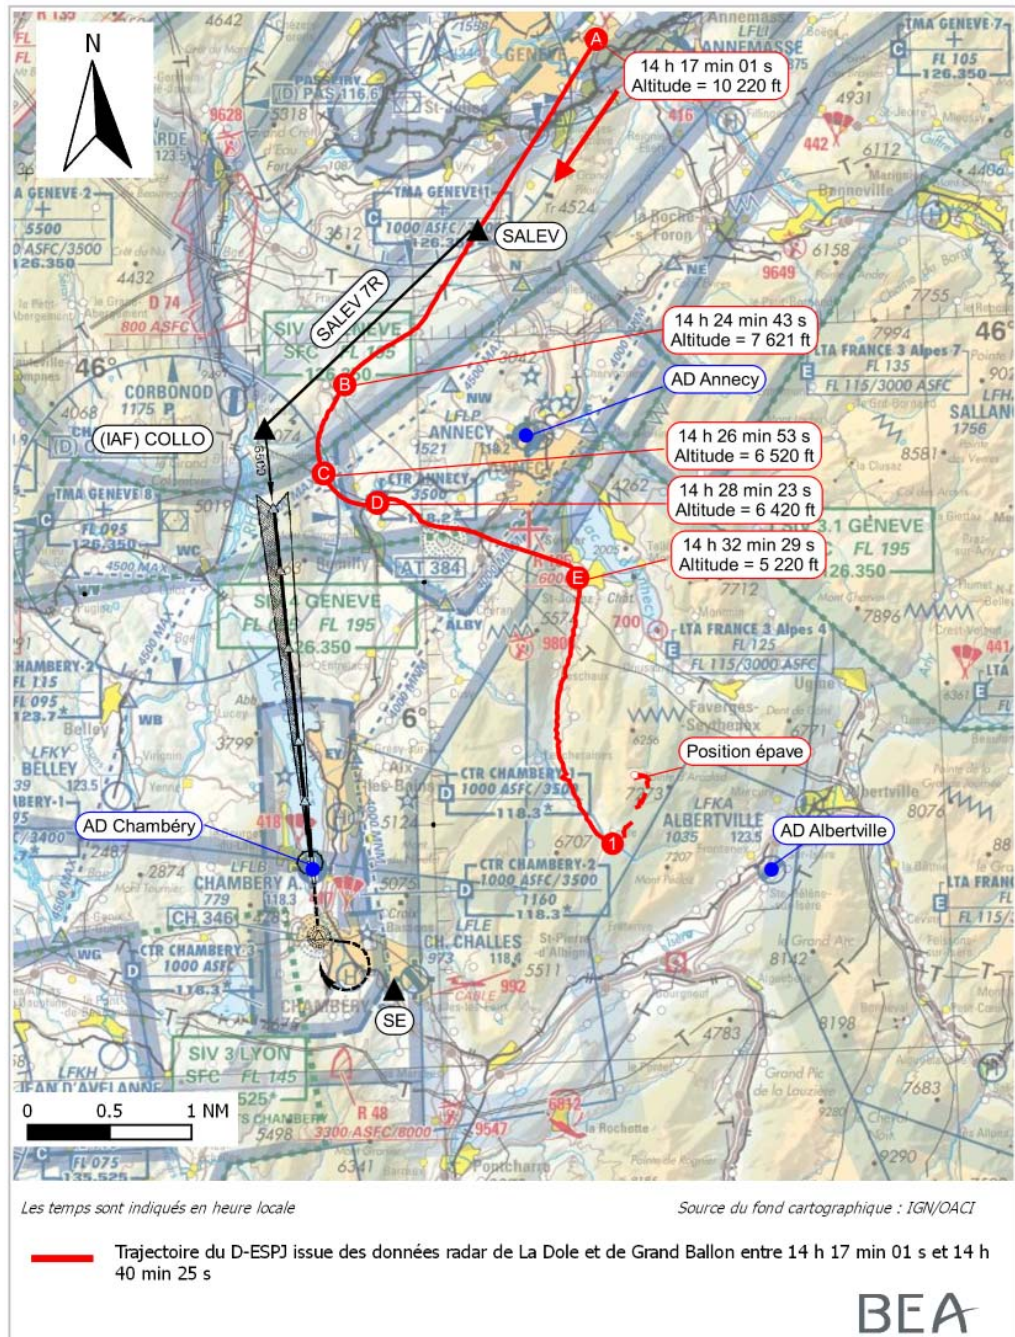
Figure 1: trajectory over the last thirty minutes flight

From that moment, there is no radio contact (4) with the driver. The driver follows a Albertville direction valley to the point 1 of the path (Figures 1 and 7) and then takes a substantially north heading uphill, before turning towards the west. The aircraft struck the mountain about ten meters below a ridgeline. Part of the wreckage was found on impact and another 280 meters down against a rock wall.

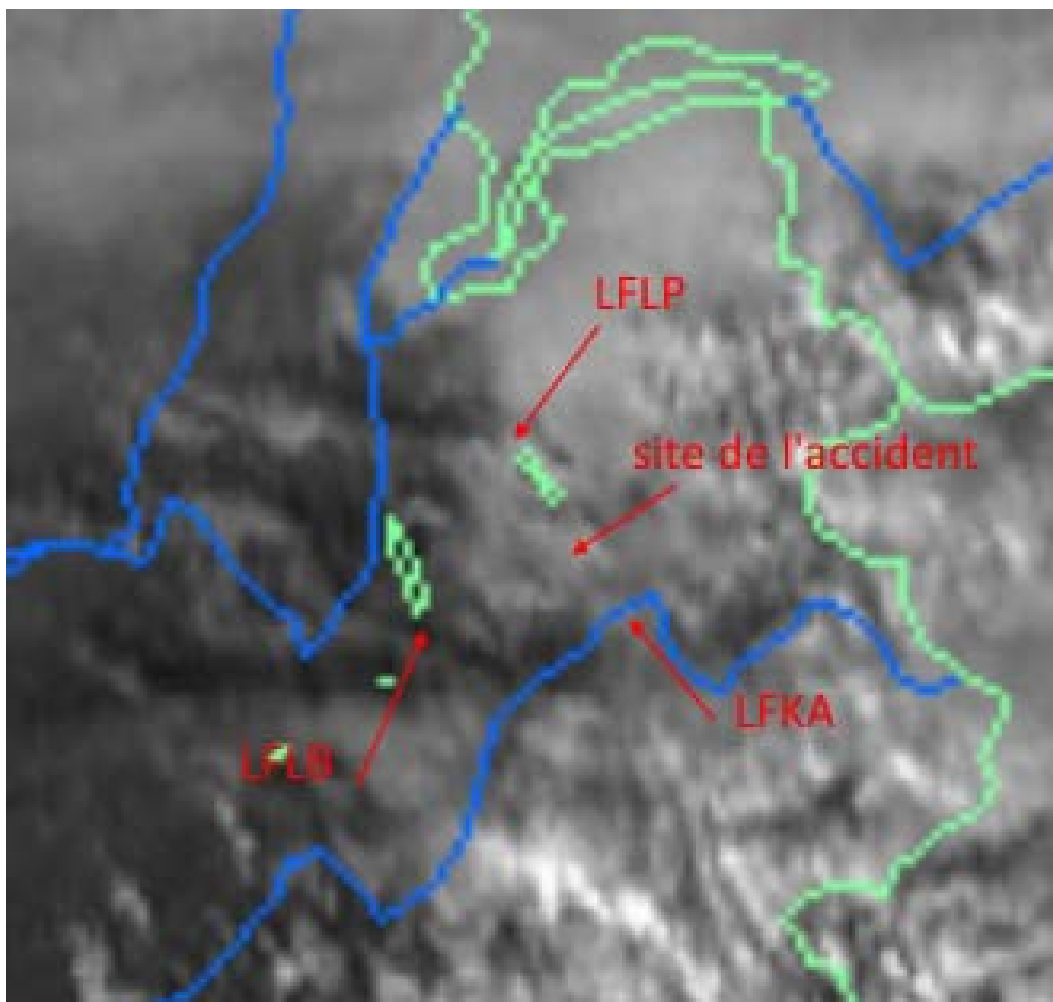
Figure 3: cloud cover at 13 h30 UTC

The trajectory to the point 1 would indicate that the pilot was changing VMC and intended to join the Isère valley. The study of the map shows that the relief is significantly rises to the south and east of this point and is a mountain range on the trajectory with peaks over 6600 ft. The coverage map cloudy (Figure 3) also shows a densification of the cloud mass on the eastern Bauges.

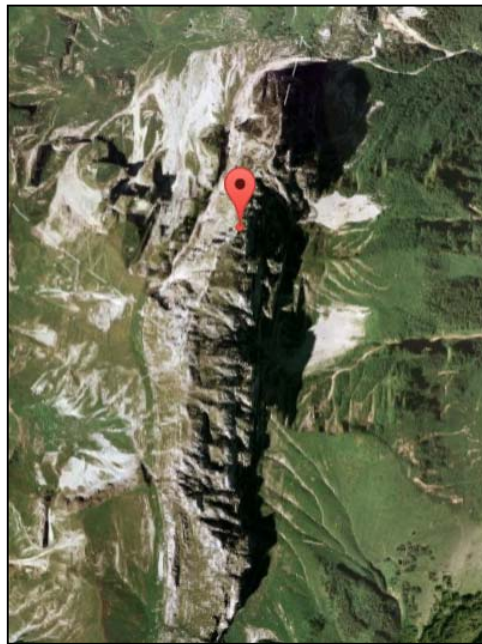
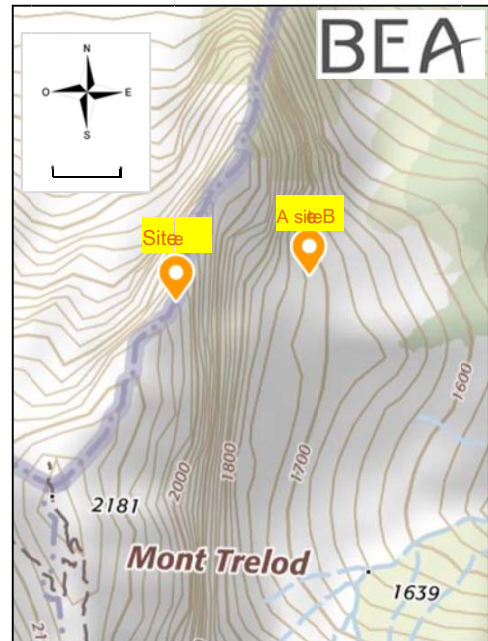
The impact site (site A, Figure 5) is located on the crest of Mount Trélod (Figures 4 and 5), about 6500 ft above sea level.

The impact took place on the east side, about ten meters from the summit. Most of the debris has been identified on the eastern side, a few fragments were found on the western slope. The fuselage and the engine have been found at the site B (Figures 5 and 6), at an altitude of about 5600 ft. Many remains are visible on the slope between the sites A and B.

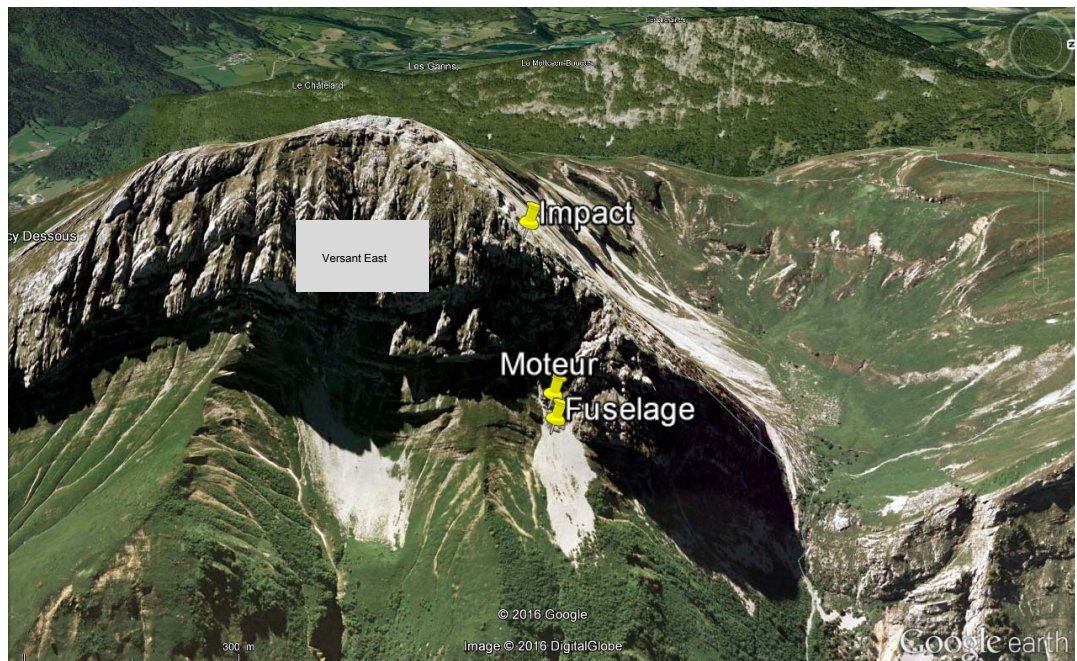
Figure 6: Location of the main elements of the relief (view from east to west)

The path of the aircraft was generally facing west at the time of the accident. The wings were torn off on impact with the terrain, the right wing has not been found. The engine on the left violently impacted terrain. Observations on the propeller blades indicates that the engine was delivering power at the time of impact with the terrain. The level of destruction of the wreck and the safety conditions on site have not enabled a review of continuity of the flight controls.

However the observations of the wreckage did not reveal any prior art impact failures of the aircraft with the terrain and suggest that the aircraft was probably rise with the wings nearly horizontal.

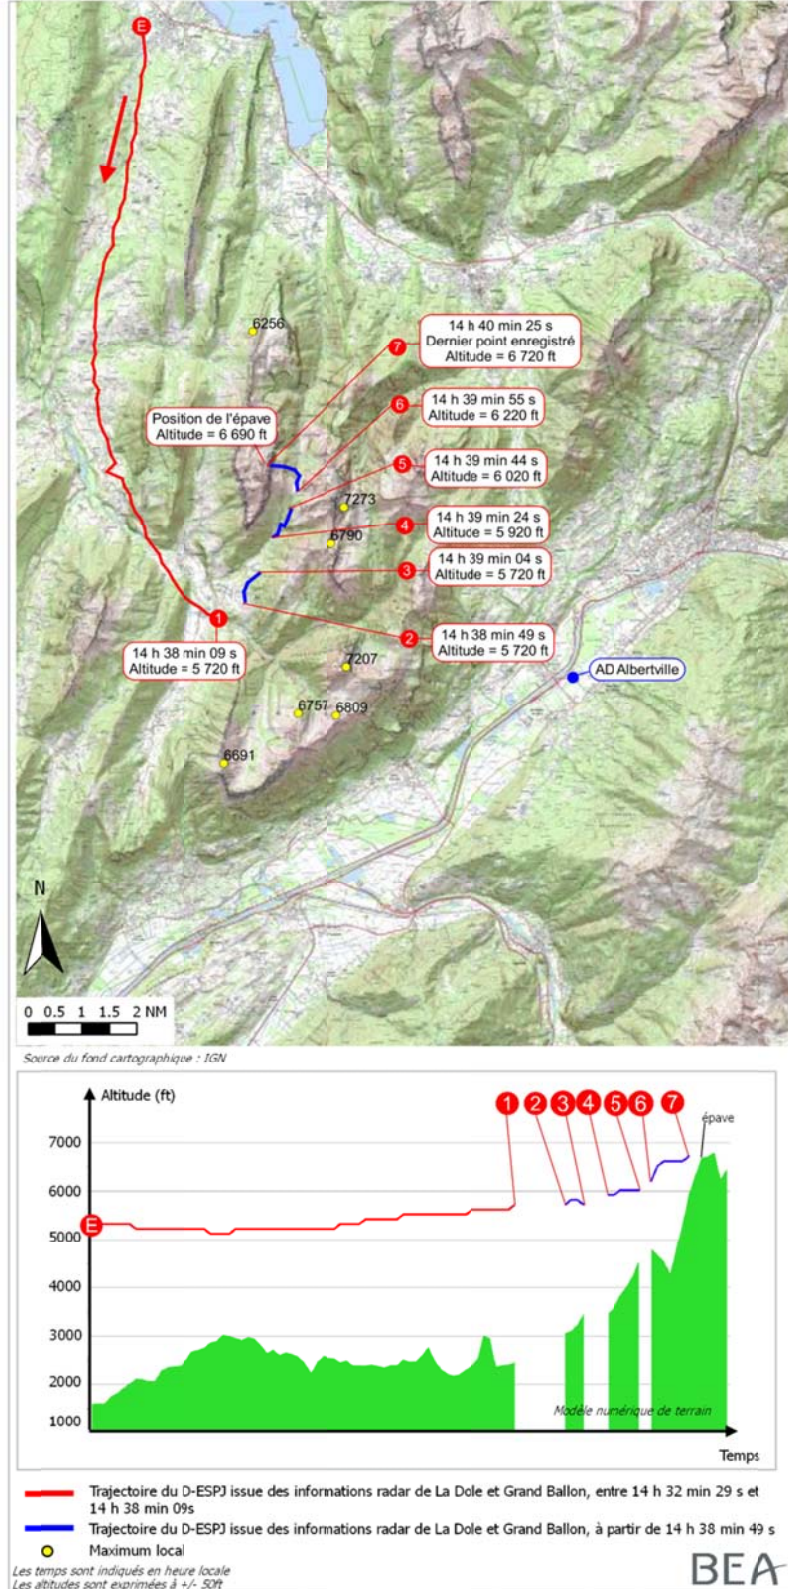
Figure 7: Final trajectory over the last ten minutes of flight

The path of the aircraft could be reconstructed from information transmitted by the various control centers (German, Swiss and French). Towards the end of the flight, the present path loss detection areas likely due to the masking of the aircraft with surrounding terrain.

The trajectory initially followed after point 1 seems to indicate an intention to head to Lake Annecy following the valley between Mount Trélod (west) and the Mount of the Coche (east) with a plane slightly uphill.

According to a witness, at the approach of Chérel Pass (4900 ft), the clouds hung on the surrounding peaks with fog banks. It is very likely that the approach to this pass, the plane has entered into IMC. The climb rate then increased significantly with the driver probably aware of the presence of the surrounding terrain. Some VFR charts on board the plane have not been found. It was not possible to ascertain what information about the relief could have the driver.

It is not possible to determine whether the left turn is the result of a deliberate action by the pilot flying or roll escaped having led to a course alteration of 90 ° undetected. The irregularities of the path also suggest that the pilot probably not using the autopilot to manage the heading and altitude of the aircraft. The attempt to turn around is very unlikely given the attitude of the aircraft observed on site during the collision with the wall.
