Investigation report

B1/2010L

Aircraft accident in Porvoo on 23 April 2010

Piper PA-28R-200 Arrow II

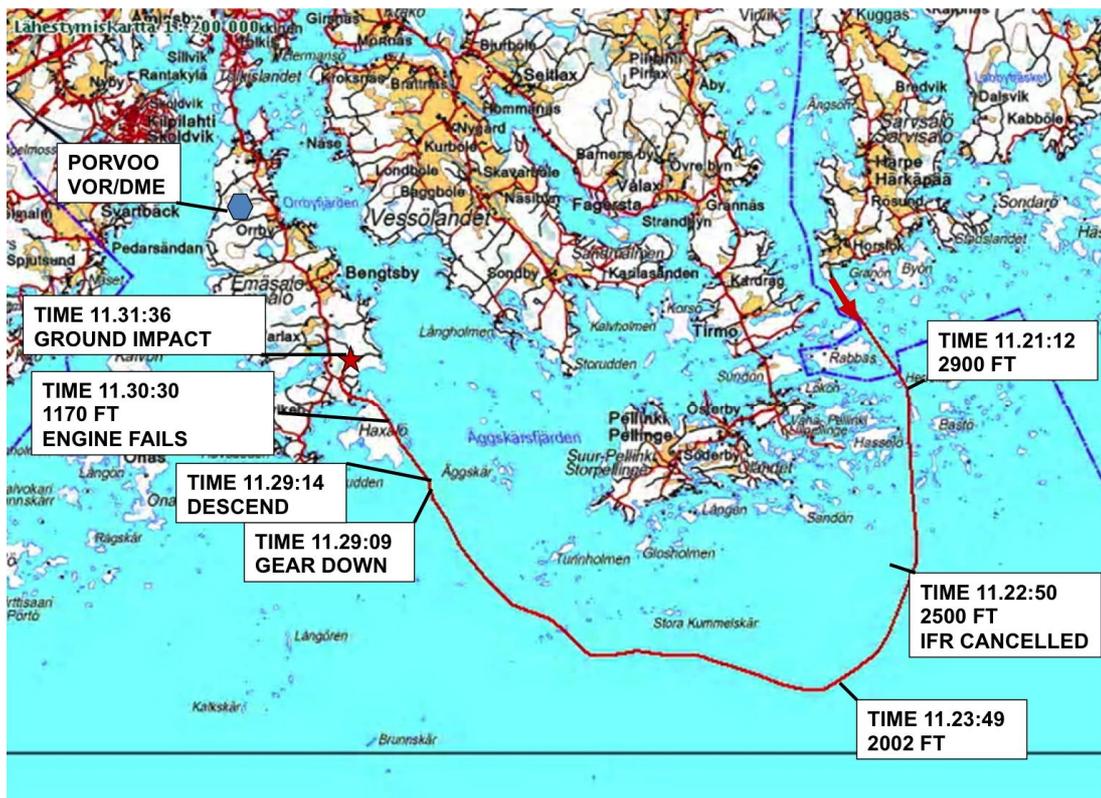
When they had descended to approximately 1300 ft (390 m) the pilot attempted to increase engine power. However, the engine did not respond. Instead, it failed. Soon after this the flight examiner took over the controls and commenced emergency procedures to restart the engine. He asked the pilot to report the engine malfunction to air traffic control. Despite the emergency procedures the engine would not restart. The flight examiner controlled the aircraft for the remainder of the flight. Prior to the forced landing the aircraft passed a GSM mast at a distance of 120 m to its side at the approximate height of 300 ft (90 m). The aircraft was destroyed in the forced landing in the woods at 11:32.

Figure 1. The profile of the flight from 11.18 onwards. Altitudes are recorded by GPS.

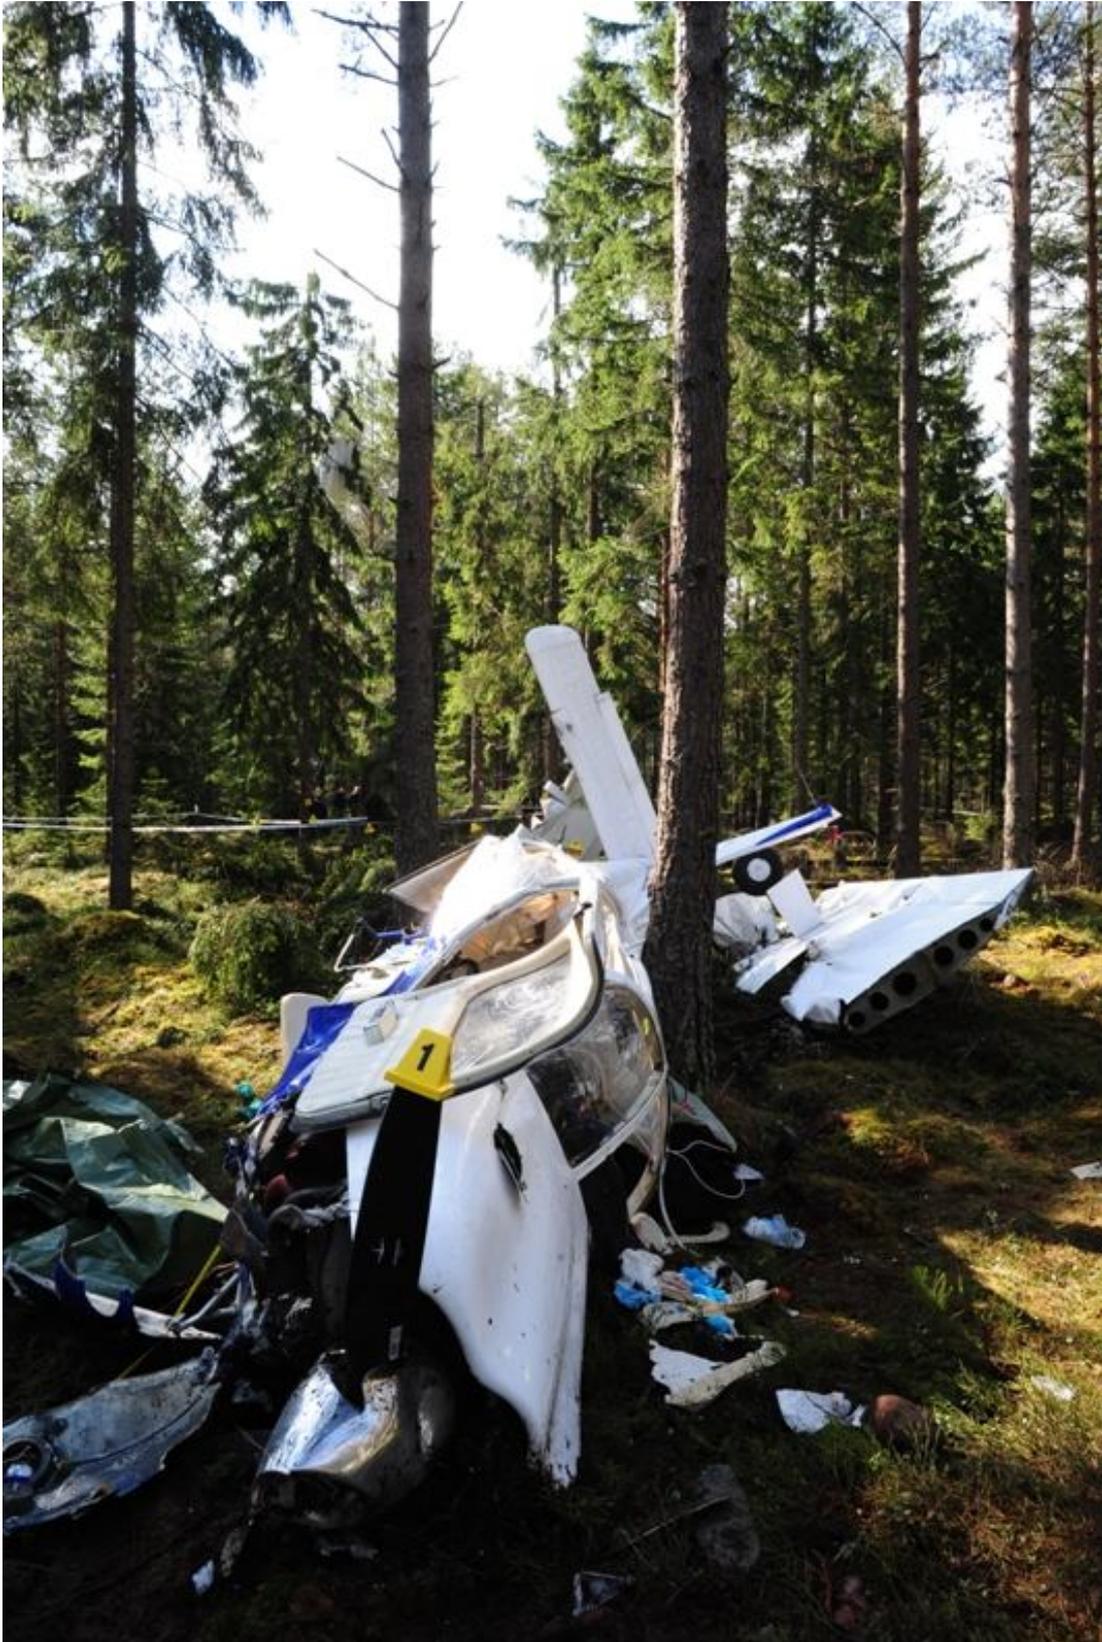
The wings hit several trees. The first contact occurred at the height of 18 m. The aircraft collided with the ground approximately 50 m from its first contact with the trees. When the aircraft collided with the trees the left wing detached at its root and, right before hitting the ground, the right wing also separated after having hit a tree. Following this, the fuselage crashed into the ground. At that time the roof of the cabin, having hit a tree, was crushed down to the bottom edge of the windows at the back.

The fuselage came to a halt in a level position, tilted at approximately 70 degrees to the left. The left side of the cockpit was deformed and crushed inwards a little, decreasing the legroom. The shoulder harness on the right front seat and the right rear seat belt were broken. The average dive angle after the first contact with trees was approximately 35 degrees.

Figure 4. The wreckage. In the background, trees broken by the aircraft.

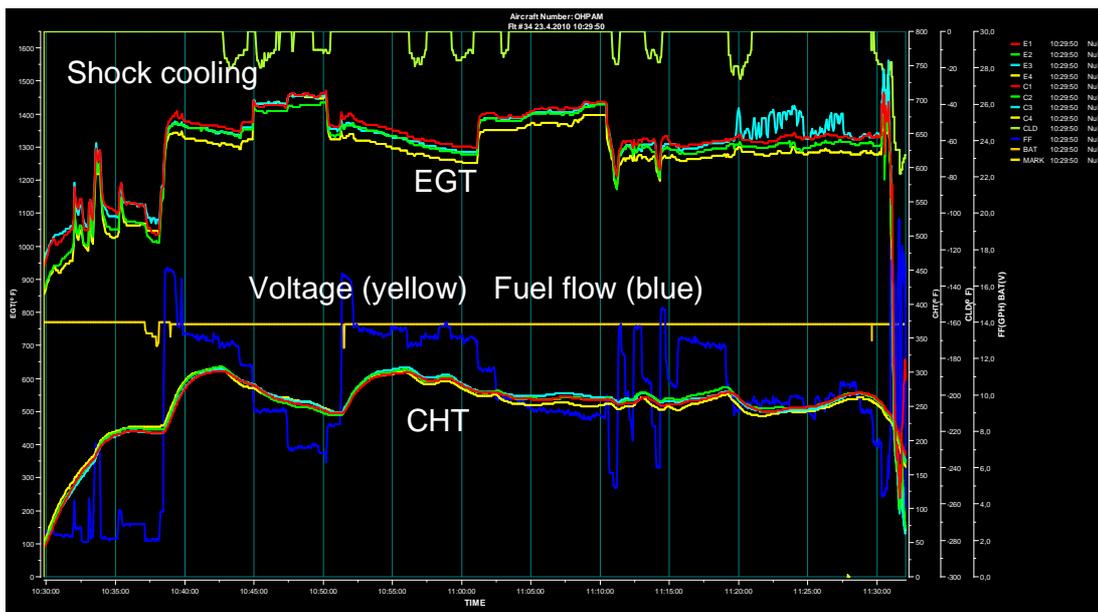
utes later fuel flow increased to its maximum rate and the EGTs began to drop, continuing to decrease to the end of the flight. Although the fuel flow rate fluctuated, it remained quite high. Simultaneously, cylinder head temperatures rapidly decreased. Approximately 17 seconds before the accident the EGT of cylinder No. 1 increased while the others continued to decrease.

Figure 5. EDM-recorded engine parameters for the entire flight. The parameters can be studied in detail by zooming into them with the manufacturer's analysis program. A more detailed analysis of the parameters is presented in figure 11.

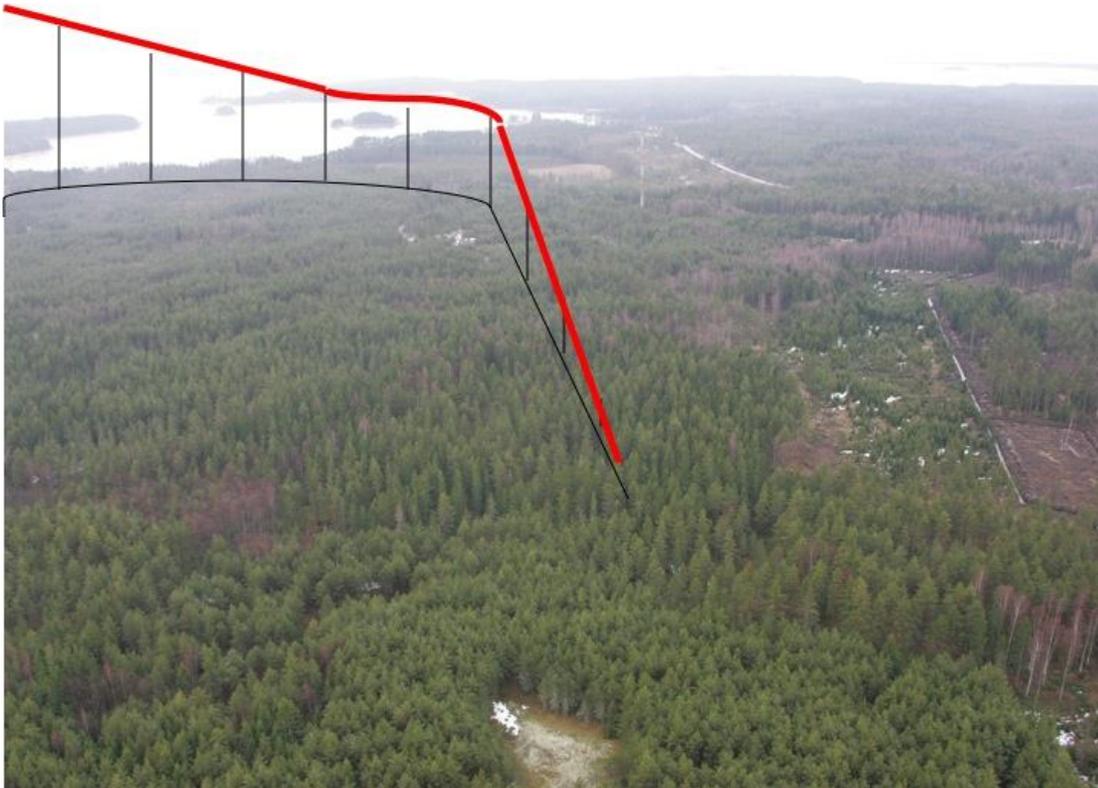
Trees in the forced landing site consisted of a tall evergreen forest. There was a nearly treeless clearance approximately 100 m to the left of the landing site. Prior to the forced landing the aircraft passed a GSM mast at a distance of 120 m to its side and at approximately 300 ft (90 m) height. It is likely that the poor visibility made it more difficult to select a landing site.

Figure 6. Aerial photo of the accident area. The red line indicates the trajectory in the air and the black line shows the flight path superimposed onto the terrain. The GSM mast is also visible in the photo.

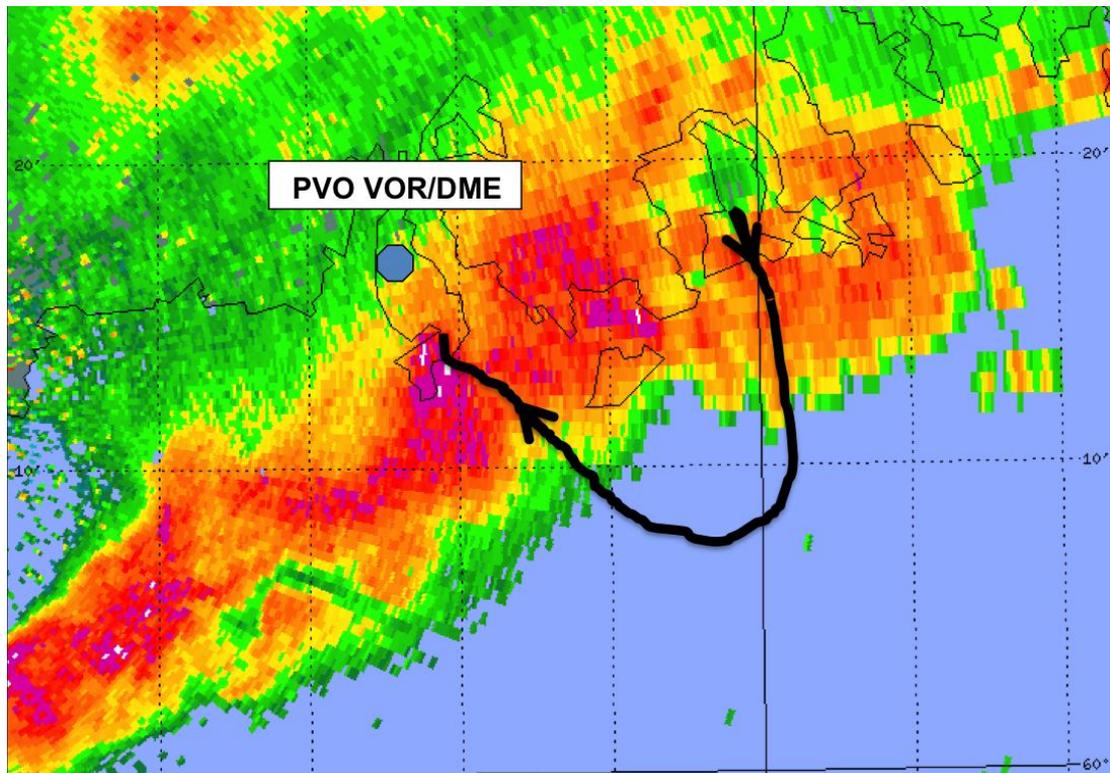
The GAFOR forecasted weak rain and snow mixed. Counter to the forecast, however, a very intense rain band formed along the coastline. Persons that were at Emäsalo before the accident said that visibility in the rain and snow was close to zero at times.

Figure 7. The aircraft's track and the rain / snow area at 11:30.

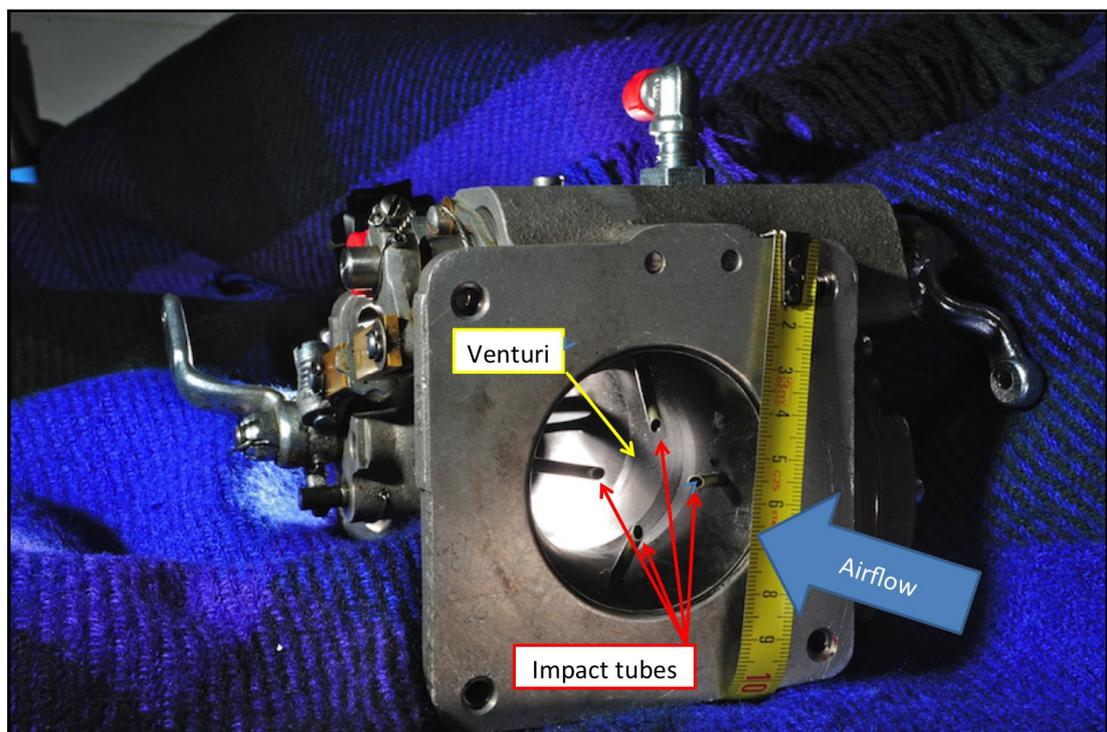
The fuel injector unit has proved to be reliable and, unlike traditional carburettors, it is not prone to icing. Nevertheless, since it has a venturi tube, its design resembles a carburettor. Flow rate increases and temperature decreases in a venturi tube, which makes icing possible in certain temperature and humidity conditions.

Figure 10. A Bendix RSA-5AD1 fuel injector unit.

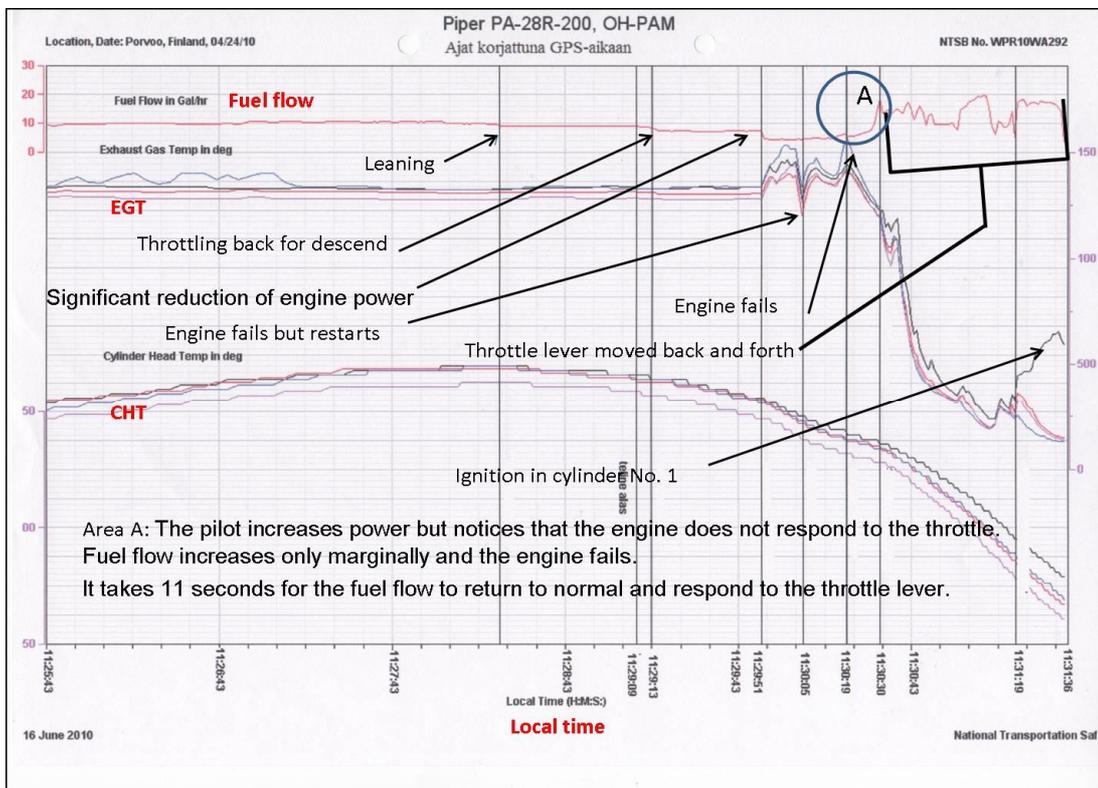
The engine malfunction that ultimately led to engine failure began at 11:29:51 at which time the EGT values surged. The fuel injector fed an insufficient quantity of fuel to the engine, which made the fuel/air mixture too lean. The fuel injector unit was found to be fully functional after the accident. The investigation commission considers it likely that the malfunction was caused by ice formation inside the fuel injector unit. Because the fuel/air mixture was not rich, this means that neither the air filter nor the intake manifold was blocked with snow or ice. Rather, the mixture was lean, which was denoted by the high EGTs and clean spark plugs. The meteorological conditions in the accident area were extremely favourable to engine intake icing. Precipitation came as a wintry mix, snow, sleet and hail, and possibly even rain. Depending on the altitude, temperature varied from zero to a few degrees below zero Centigrade.

Figure 11. Engine parameter analysis from the terminal phase of the flight.
