Service Bulletin

April 26, 1999 SEB99-5

WING FUEL TANK VENT CHECK VALVE INSPECTION

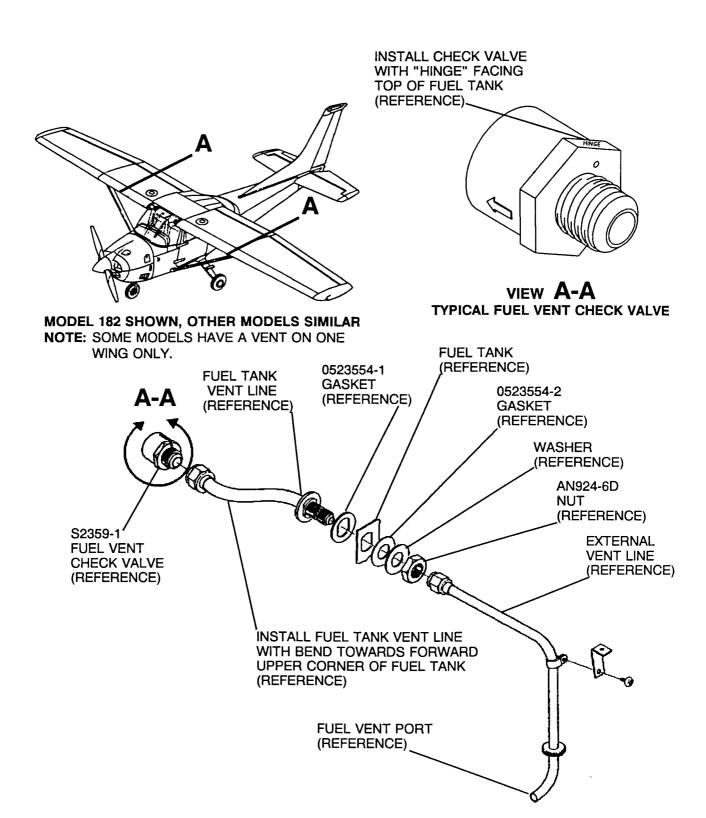
Figure 1. Fuel Vent Check Valve Inspection (Sheet 1 of 1)

A report has been received which indicates that a part number S2359-1 Fuel Vent Check Valve was obstructed and caused a greater than ambient pressure to occur in the wing fuel tank (wing fuel tank pressurization).

This condition, if not corrected, may allow pressurization of the wing fuel tank which could result in a wing and/or wing fuel tank structural failure.

3. (Refer to Figure 1.) Locate the applicable wing fuel vent port of the affected S2359-1 Fuel Vent Check Valve.

- G. Drain fuel from wing fuel tank and gain access to the S2359-1 Fuel Vent Check Valve. Remove and replace the S2359-1 Fuel Vent Check Valve.
 - (1) The following procedures applies to airplanes equipped with metal fuel tanks. Refer to Figure 1., gain access to the top of the fuel tank. Disconnect the external vent line from the fuel tank vent line.

- (3) Remove fuel tank vent line and gasket, discard gasket, and pull safety wire through fuel tank and secure end of safety wire.
 - (4) Replace S2359-1 Fuel Vent Check Valve and install on fuel tank vent line as shown in Figure 1.

- (5) Using the safety wire, pull new 0523554-1 gasket, fuel tank vent line and check valve through fuel tank and position as shown in Figure 1.
