**Loss of pitch control, collision with the ground  
on entering the aerodrome traffic pattern**

<b>Aircraft</b>	Cessna C152 registered F-GLPO
<b>Date and time</b>	Sunday 8 January 2012 at 17 h 13 <sup>(1)</sup>
<b>Operator</b>	Club
<b>Place</b>	Moisselles (95)
<b>Consequences and damage</b>	Pilot and female passenger killed, aircraft destroyed

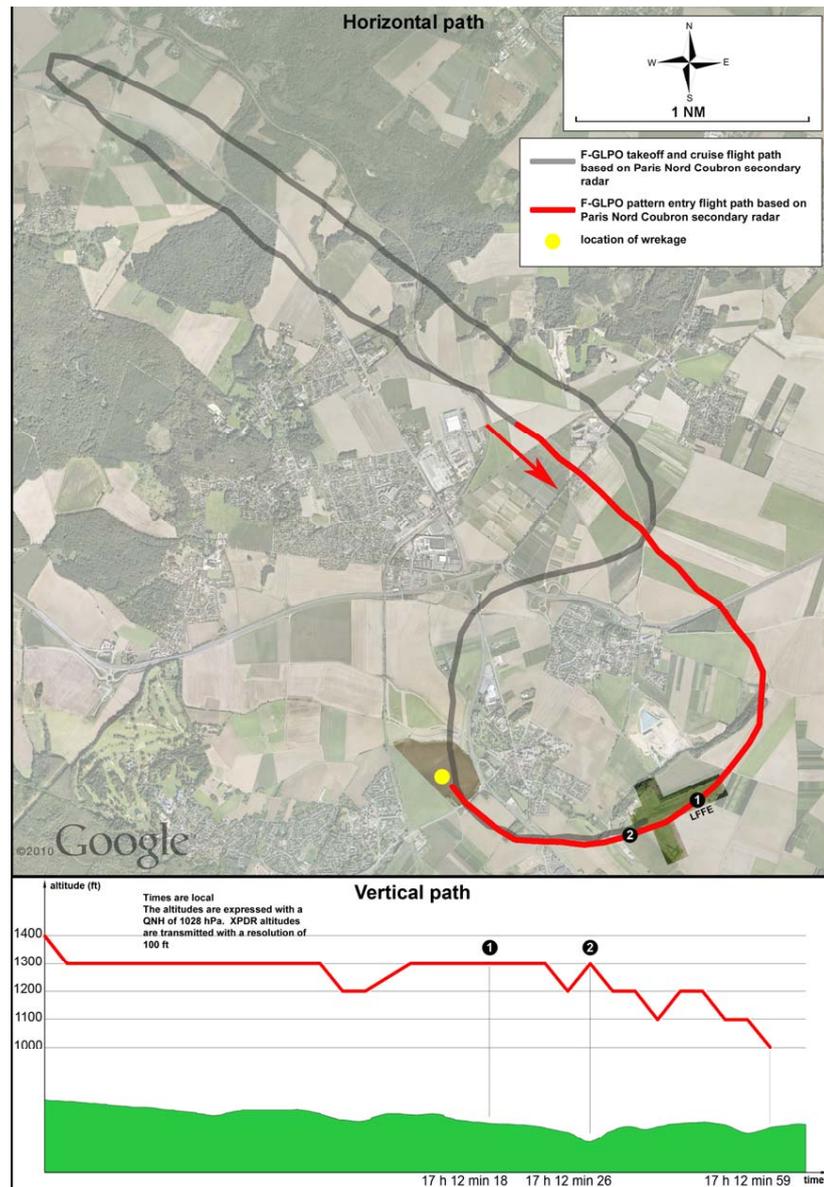
The pilot, accompanied by a female passenger, took off at 17h04 for a local flight of about ten minutes from unsurfaced runway 25 of Moisselles aerodrome. Radar data showed that he followed the mandatory route as far as the CTR limit (see figure 1), then turned back and returned by the same route. The pilot was flying at an altitude of about 1,400 ft. He then began to enter the pattern for the right hand downwind leg to runway 25. The last recorded position at 17 h 13 was in crosswind at a height of about 700 ft. The wreckage was found close to this position in a field with no obstacles, about 1 NM west of the aerodrome.

Figure 1: Flight path plotted from radar data

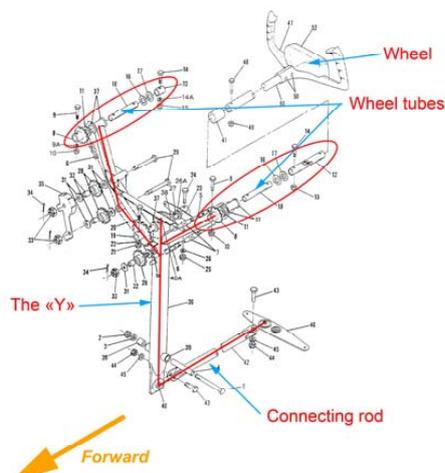
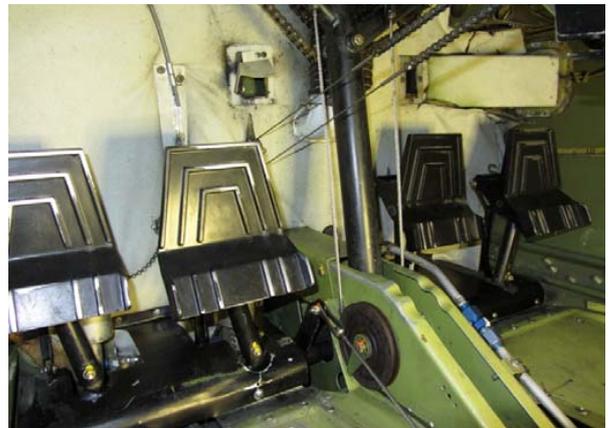
Cessna and Reims Aviation 150/152 are equipped with two wheels enabling pitch and roll attitude to be controlled. The wheels are linked behind the instrument panel by a set of tubes forming a "Y". In the cockpit, the vertical branch of the "Y" goes behind the instrument panel, between the rudder pedals. There is a system of chains and transmissions on the "Y" in order to transmit the roll inputs.

Figure 2: Overview of the pitch control system in the cockpit

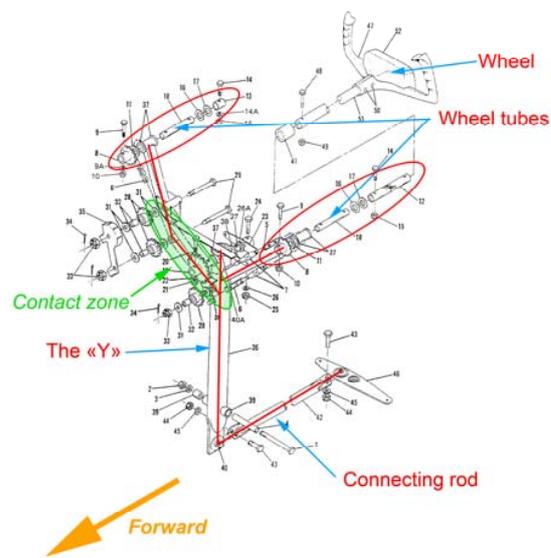
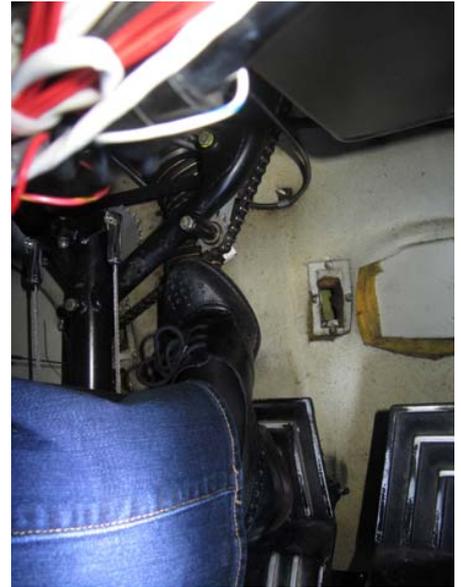
A simulation on the ground was carried out with a person of similar weight to the female passenger in the accident. The tests showed that it is possible when sitting on the right seat to put the tip of one's left foot on the elevator control transmission, while retaining a natural, comfortable posture (leg stretched out or slightly bent). This posture is consistent with the passive attitude that a passenger may have. Without exerting great pressure with the left foot, a passenger may easily put the elevator control transmission in full pitch-down position, without disrupting roll attitude. Under test conditions it was not possible to counter this action with inputs on the wheel.

Fig. 3 – Interference with the foot on the elevator control transmission (at the level of the chain)

The investigation showed that it was possible for a passenger in the right side seat to push the elevator control transmission with their left foot, causing the aeroplane to pitch nose down. Such an action is compatible with a natural, comfortable posture for a person the size of the female passenger. The observations made suggest that the pilot was probably making an input on the elevator control wheel with two hands at the time of the accident. This attitude is consistent with that of a pilot trying to counter a pitch-down input.

- **The Federal Aviation Administration ensure that Cessna Aircraft Company informs the owners of Cessna and Reims Aviation 150/152 of the possibility of a passenger making a pitch-down input by inadvertently operating the elevator control system located close to the rudder pedals; [Recommandation FRAN.2013.015]**
- **EASA inform the European national civil aviation authorities of the potential risks on Cessna and Reims Aviation 150/152 of a passenger causing a pitch-down input, by inadvertently operating the elevator control system located close to the rudder pedals. [Recommandation FRAN.2013.016]**

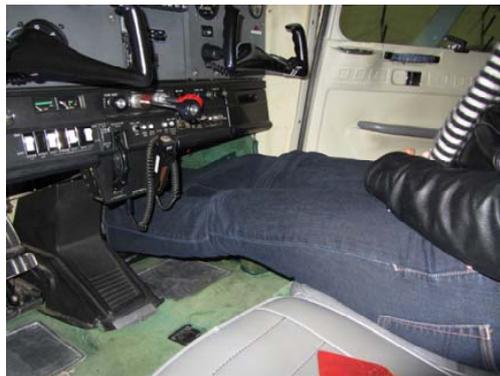
Fig. 4 – Posture with seat pushed back

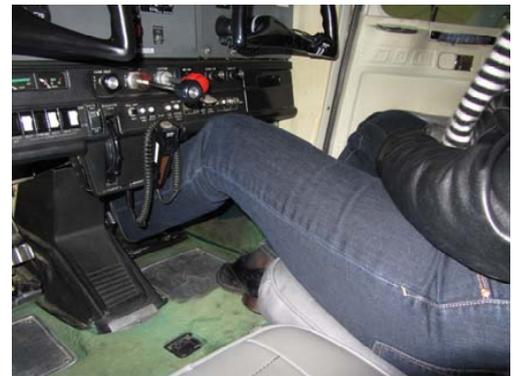
Fig. 5 – Posture with seat pulled forward
