SERVICE BULLETIN

TB AIRCRAFT

SB 10-152

SUBJECT : HORIZONTAL STABILIZER INTERNAL STRUCTURE

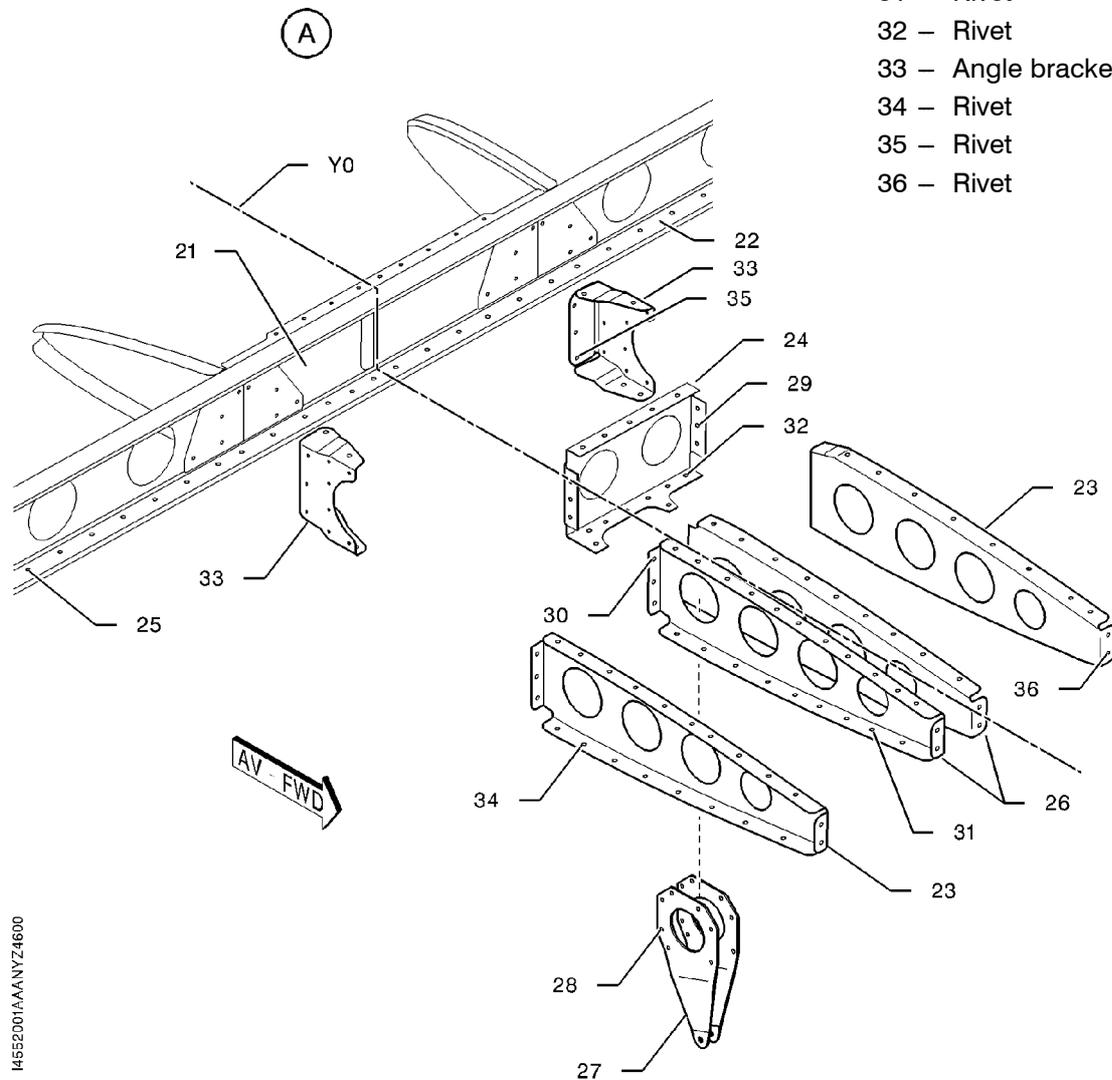
Figure 4 – Removal of ribs

IF SPAR WEB (21) AND SPAR FLANGE (22) ARE AFFECTED BY CORROSION, HORIZONTAL STABILIZER MUST BE REPLACED BEFORE NEXT FLIGHT – REFER TO CHAPTER 55-20-01 OF THE MAINTENANCE MANUAL.

IF SPAR WEB (21) IS AFFECTED BY CORROSION AND SPAR FLANGE (22) IS NOT, CONTACT DAHER (*).

IF CORRODED AREA “Y” IS NOT COMPRISED BETWEEN – 14.37 IN (– 365 MM) AND 14.37 IN (365 MM), HORIZONTAL STABILIZER MUST BE REPLACED BEFORE NEXT FLIGHT – REFER TO CHAPTER 55-20-01 OF THE MAINTENANCE MANUAL.

- 5) Remove rivets (25).
- 6) Measure Y min and Y max positions of the corroded area.
- 7) Remove corrosion – refer to Chapter 20–00–04 of the Maintenance Manual.
- 8) Measure the minimum remaining thickness (51).
- 9) Apply the procedure according to the table hereunder :

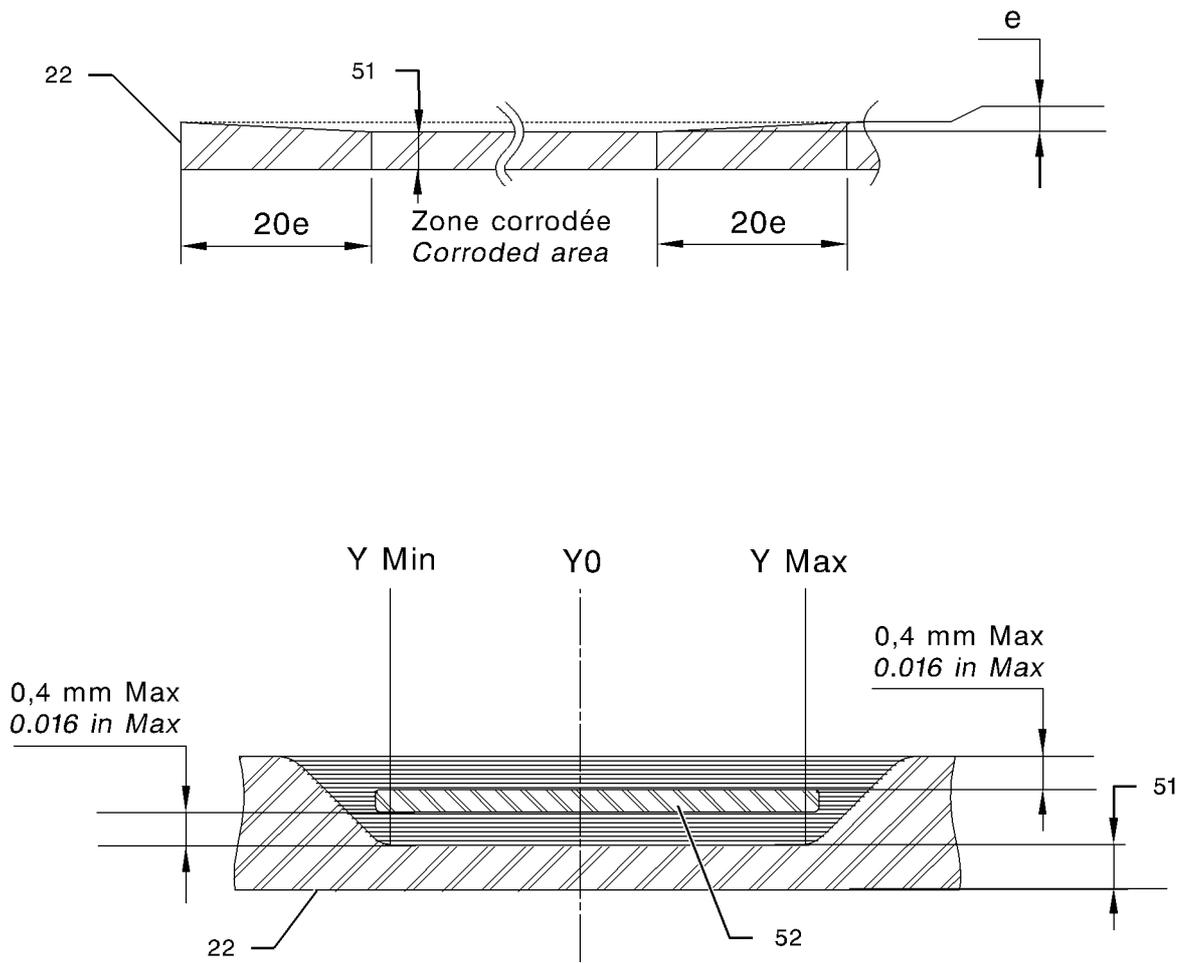
Figure 5 – Preparation of corroded area

CORRODED AREA ON THE SPAR FLANGE (22) GEOMETRICAL CHARACTERISTICS		AIRCRAFT TYPE	
T : minimum remaining thickness (51)	Y : Y max and Y min positions of the corroded area	TB09 TB10 TB200	TB20 TB21
$T \geq 0.11 \text{ in (2.8 mm) AND}$ $- 3.54 \text{ in (- 90 mm)} \leq Y \leq 3.54 \text{ in (90 mm)}$		TYPE OF REPAIR	
		Type 1 repair Apply Parag. D.	Type 2 repair Apply Parag. E.
$0.098 \text{ in (2.5 mm)} \leq T < 0.11 \text{ in (2.8 mm) OR}$ $-14.37 \text{ in (- 365 mm)} \leq Y \leq 14.37 \text{ in (365 mm)}$		Type 3 repair Apply Parag. F.	
$0.087 \text{ in (2,2 mm)} \leq T < 0.098 \text{ in (2,5 mm) AND}$ $-14.37 \text{ in (- 365 mm)} \leq Y \leq 14.37 \text{ in (365 mm)}$		Type 3 repair Apply Parag. F.	
T < 0.087 in (2,2 mm)		Replace horizontal stabilizer

- 1) In compliance with Figure 5, eliminate sharp edges on corroded area.
- 2) Inspect the corroded area to check absence of cracks – refer to Chapter 20–00–14 of the Maintenance Manual.

- 3) Vacuum working area.
 - 4) Protect bare metal with Alodine 1200 and epoxy primer.
 - 5) Prepare a compound with adhesive Hysol 9394.
 - 6) Fill and level corroded area with adhesive Hysol 9394. If necessary, insert shim (52).
