## ANNEX 5

*SUBJECT: PH-UBG Investigation Report on aircraft structure*

Accident SOCATO TB21, imm. PH-UBG, dated 10/04/2001 at Neeroeteren.

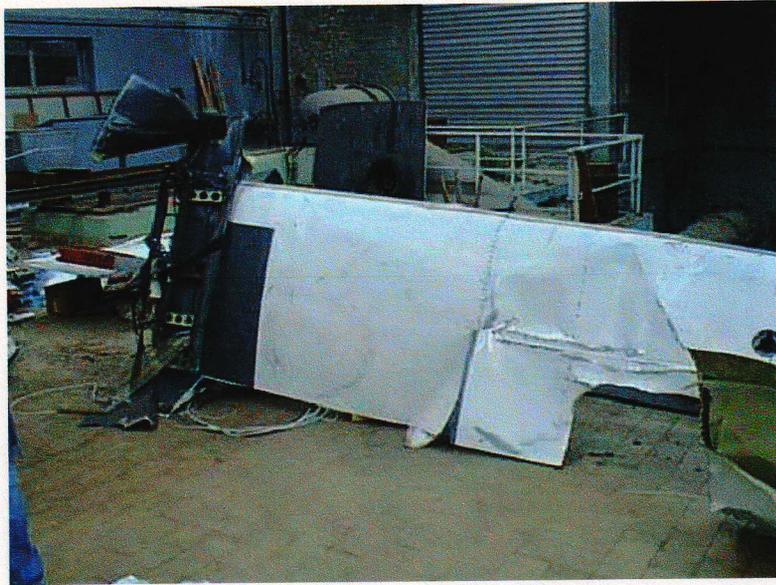
The web of both I-beams shows widespread inelastic buckling. This indicates the beams have been loaded beyond their design load. The deformations are organized in a regular buckling pattern, indicating an overload in shear stress.

Parts of the side panels of the cockpit remained attached to the wings and are bend over, lying almost parallel to the upper wing surface. This also indicates the wings have bend over to the top, confirming the positive bending of the wing at failure. This is confirmed again by the way the flaps control rod and some hydraulic tubes have been bend (and broken).

Pictures 1 and 2 show the central portion of the left and right wing. Note the position of the side panels of the fuselage, the buckling patterns on the spar web and the bended tubes and rods.

Picture 1 : Top view of the right hand wing. Note the bent fuselage sides at the wing root.

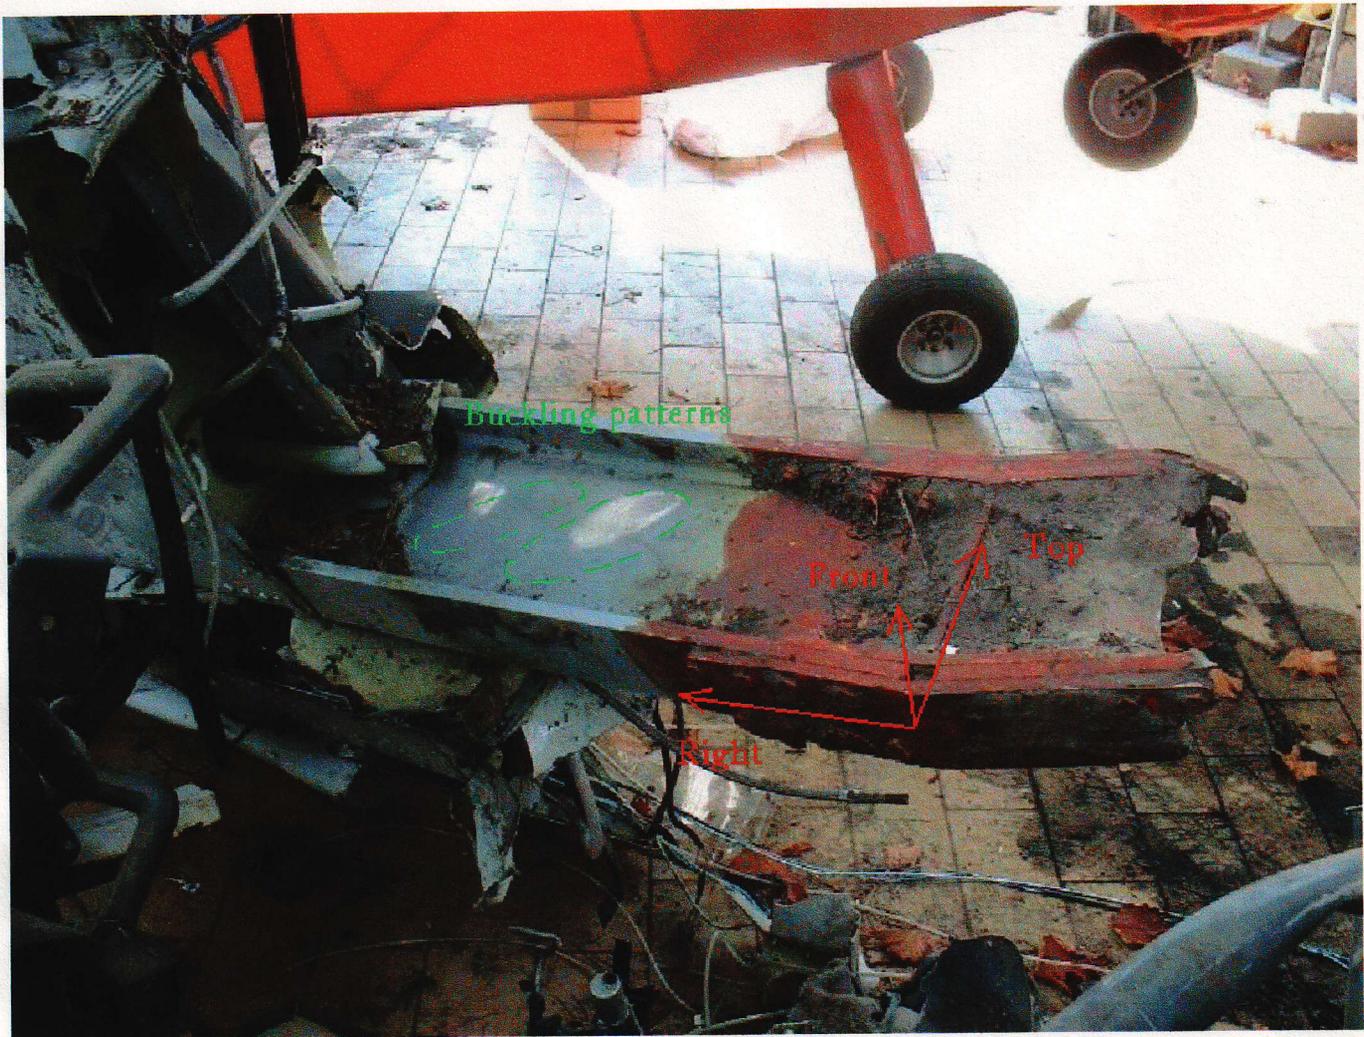
A more detailed analysis of the buckling patterns on the wing spar is given in appendix 1. This analysis indicates the orientation of the excessive shear stresses on the beam. The buckling patterns are compatible with an excessive load during a roll to the left.

The center portion of the wing spar has failed due to an excessive positive bending moment, combined with excessive shear stress, due to an unsymmetrical and excessive wing loading. The buckling patterns indicate the right hand wing has produced a significantly higher lift than the left wing (right roll).

Picture 2 : Right hand portion of main spar. Buckling patterns and parts orientation are highlighted. The bent hydraulic tubes and control rods are clearly visible.

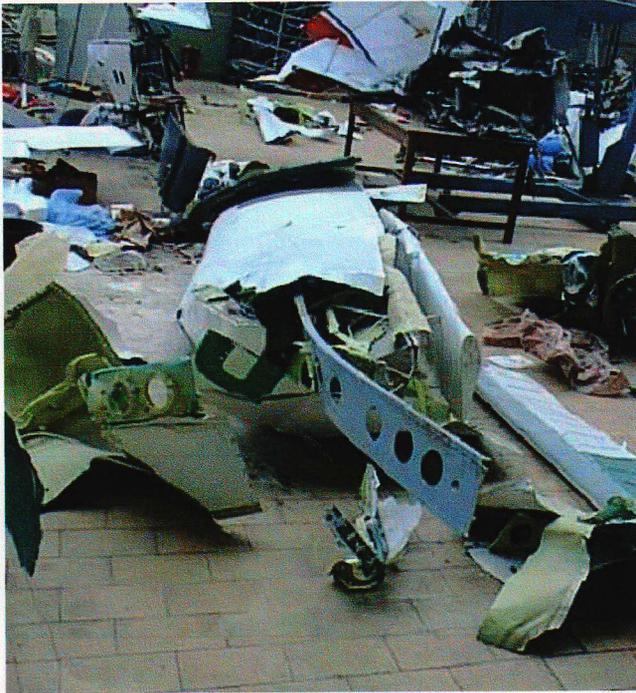
The outer wing panels, from the end rib of the fuel tank to the wingtip, as well as the aileron have been torn apart from the main structure in flight. The main wing spar remains attached to the wing, but is bent towards the top and towards the rear side of the aircraft.

The aileron has suffered global buckling, pointing towards excessive compression loads in the direction of its axis. This indicates the aileron was still attached to the aircraft when the wing was suffering severe deformation.

Around the hinge at the wing tip, marks indicate the wing-skin and rib have impacted heavily against the top part of the aileron. This confirms the belief that the outer wing part was ripped off towards the top.

Picture 3 shows the remains of the left hand wing.

The outer portion of the left-hand wing has disintegrated following an excessive positive loading (positive lift on wingtip).

Picture 3 : Remains of the left hand wing. The main spar is bent towards the top and the rear.

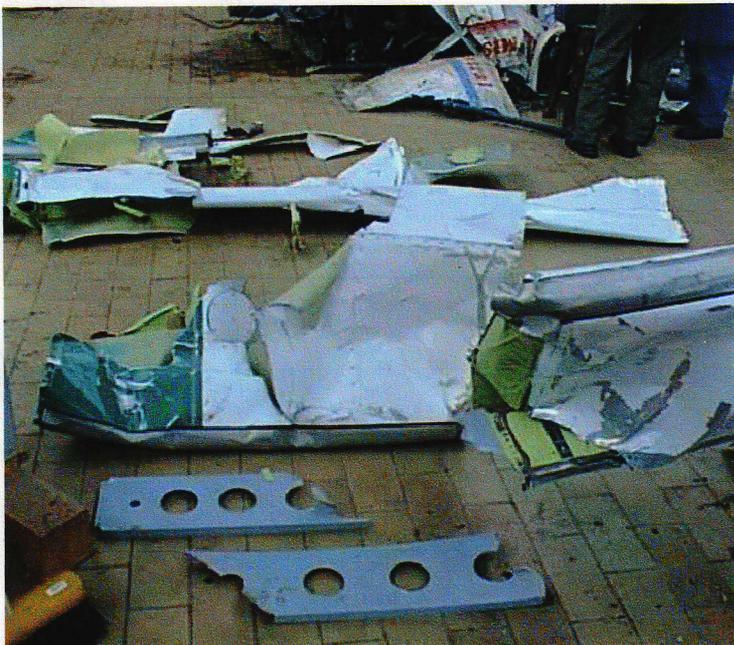
The outer wing panels, the aileron and part of the flaps are torn apart from the main structure. The main wing spar is broken at two points, between the center fuel tank and the wingtip. The fracture zone indicates clearly the debris was evacuated towards the top and, in first instance, towards the front of the aircraft.

The damage on the leading edge near the fuel tank and on the central wing spar indicates clearly the wingtip was "rolled-up", starting from the wingtip.

Picture 4 and 5 show the remains of the right hand wing tip.

The outer portion of the right hand wing has disintegrated following an excessive positive loading (positive lift on wingtip).

Picture 4 : Leading edge of the right hand wing tip. The nose of the leading edge shows clearly that the wing skin has been "rolled up" towards the top.
