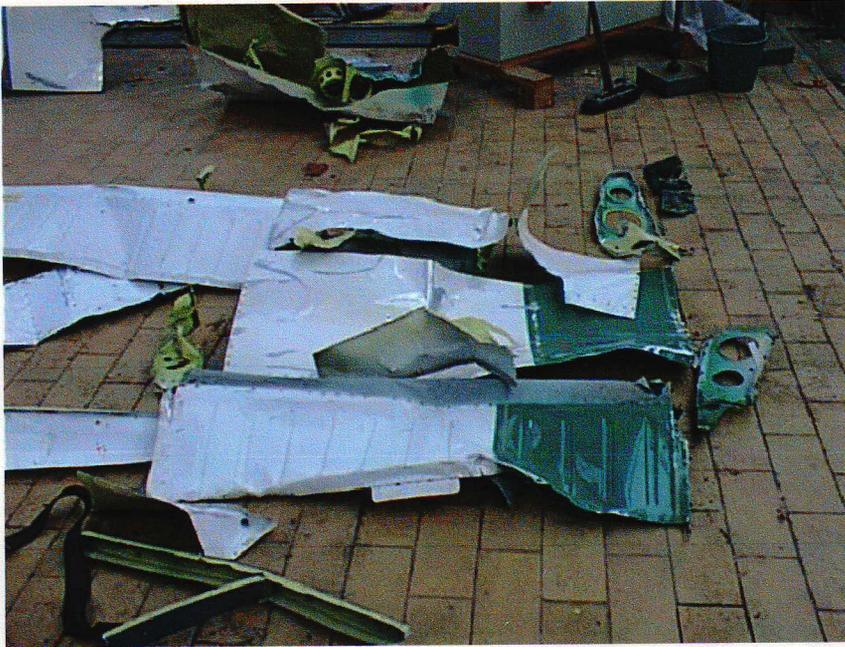
Picture 5 : Remains of the upper wing skin and aileron of the right hand wing tip.

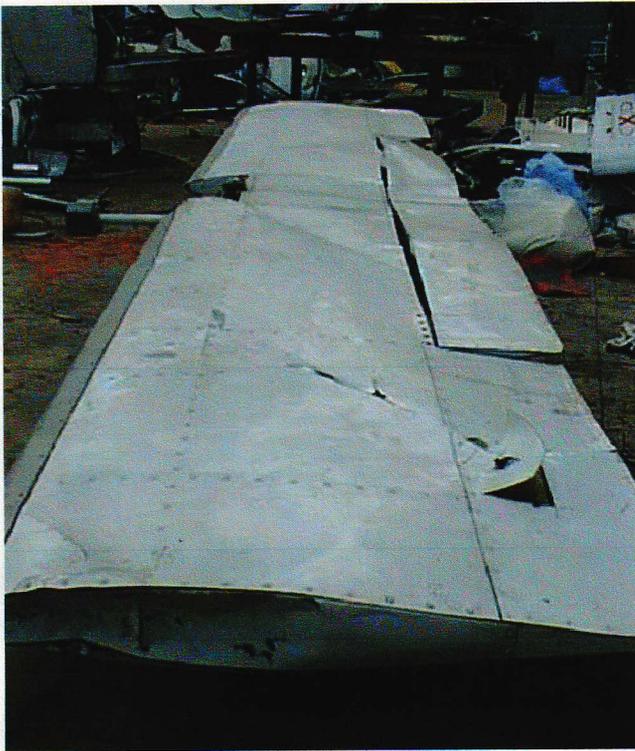
Picture 6 : Horizontal stabilizer. Note the deformation towards the rear, the buckled trim tabs and the scar on the left hand side.

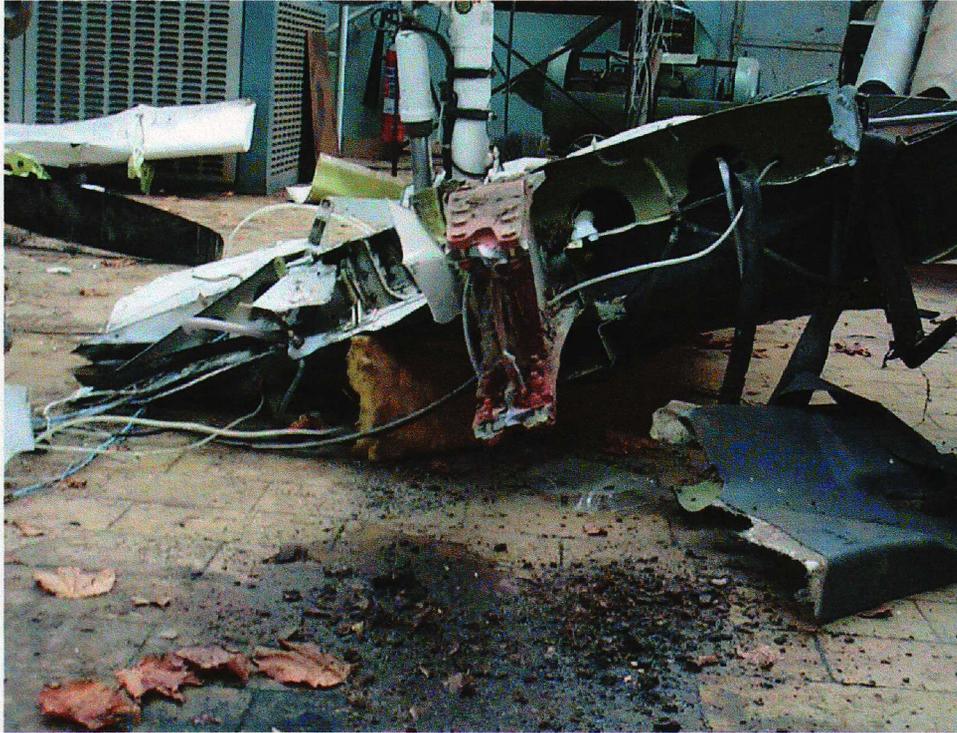
Picture 7 : View on the remains of the RH wing. Note the gear standing up from the wing, indicating the wing lies with its upper surface down. Note the I-beam in the middle of the picture where the fracture occurred.

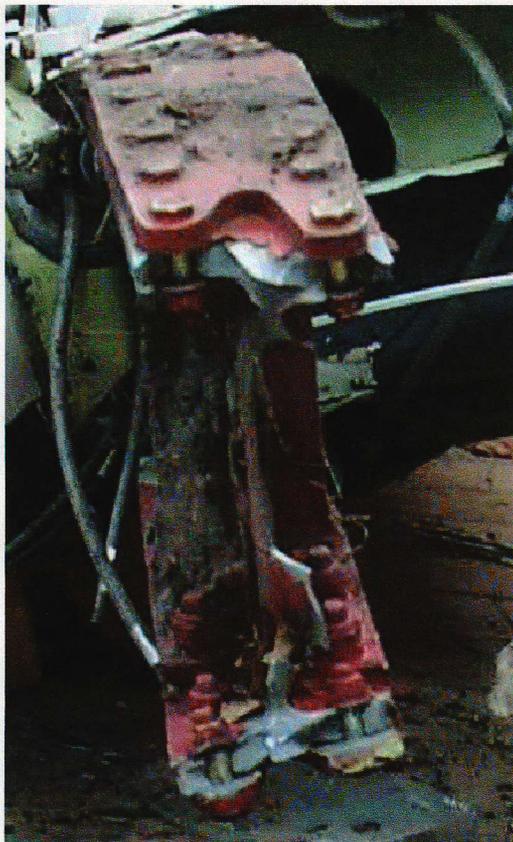
Picture 8 : Detail of the RH wing I-beam from picture 1. The fracture surface shows chevron marks typical of fast overload failure (appears often macroscopically as a brittle failure with a microscopically ductile overload behavior).
