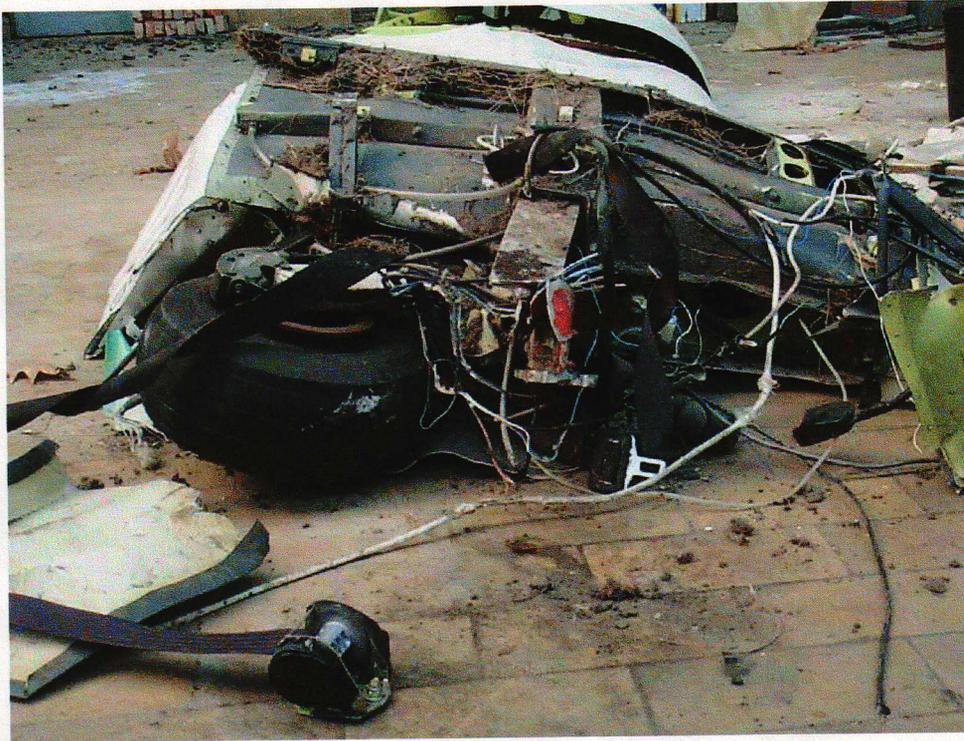
Picture 9 : View on the remains of the LH wing. Here the wing lies with its upper surface up. Note the I-beam in the middle of the picture where the fracture occurred.

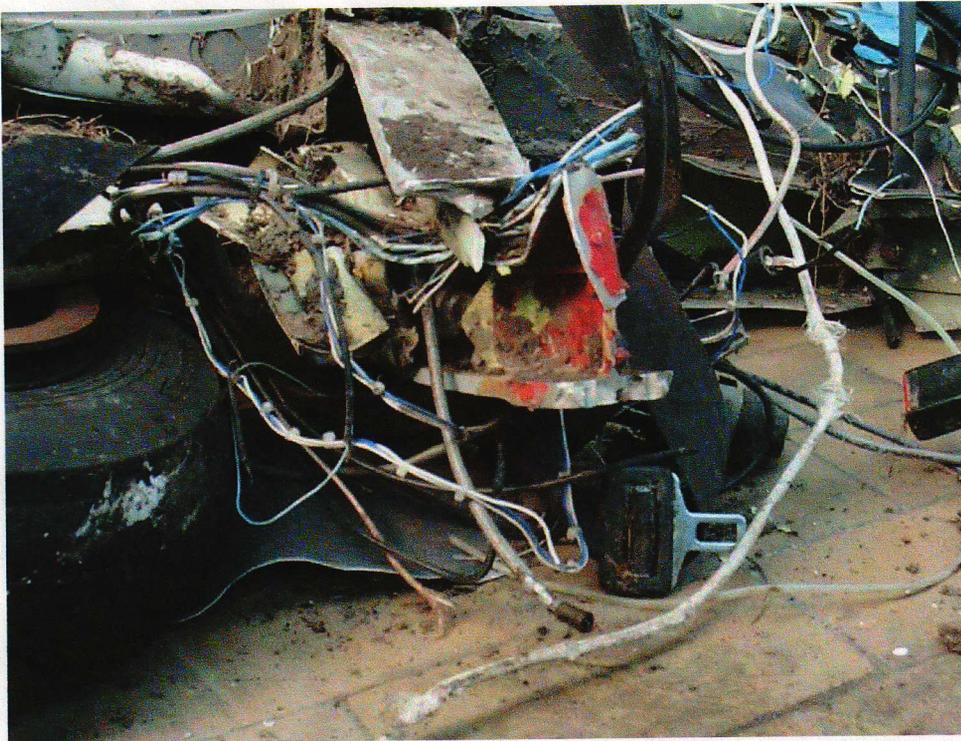
Picture 10 : Detail of the LH wing I-beam from picture 1. The fracture surface shows chevron marks typical of fast overload failure. Note the heavy deformation attributed to the collapse of the spar web.
