Investigation report

B1/2010L

Aircraft accident in Porvoo on 23 April 2010

Piper PA-28R-200 Arrow II

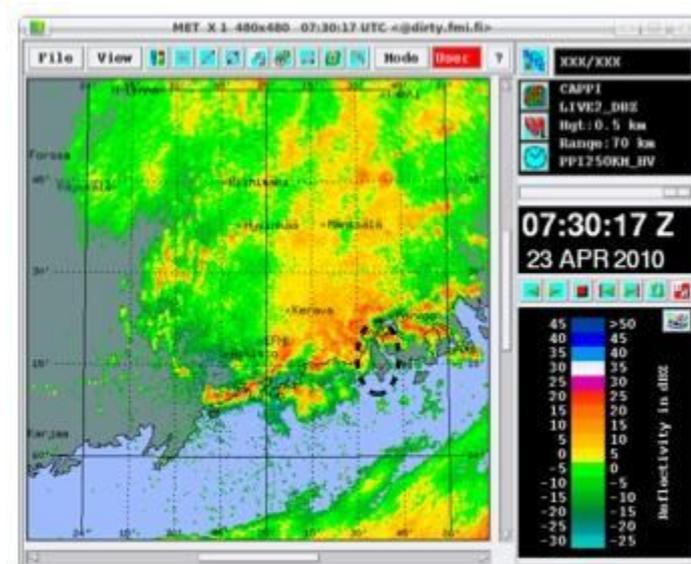
Figure 2. Weather radar image at 10:30. The developing rain band is visible over the coastline. It is still dry at Emäsalo (marked by an oval).

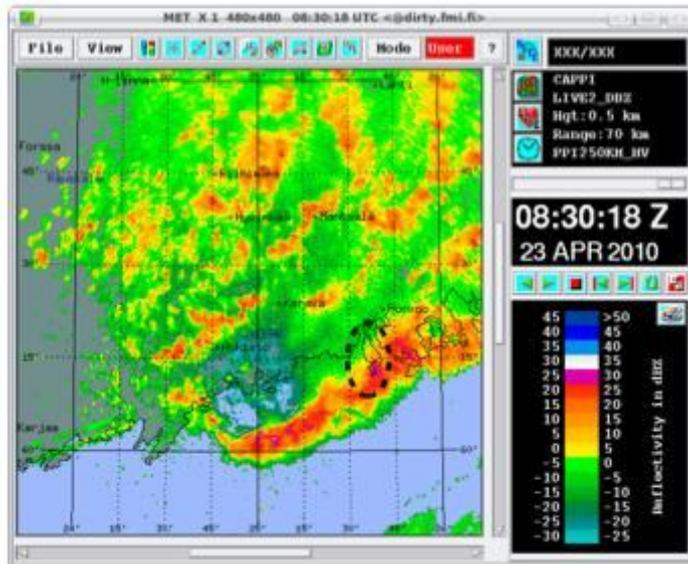
Figure 3. Weather radar image at 11:30. The intensifying rain band is moving south-southeast and has passed or is just about to pass over Emäsalo.
